**Khazar Zeynalov**  
*PhD (Art Study), Associate Professor*  
*Institute of Architecture and Art of ANAS*  
*(Azerbaijan)*

## **TYOLOGICAL CHANGES OF ARTISTIC COMPOSITIONS IN THE RESTORATION OF ARCHITECTURAL MONUMENTS IN NAKHCHIVAN IN THE MODERN PERIOD**

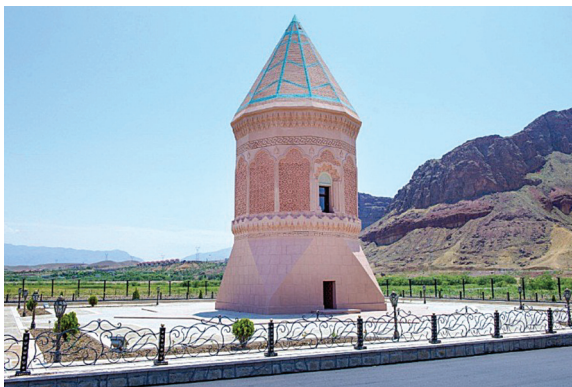
**Fig. 2. Gulistan Mausoleum. After restoration.**

The Gulustan Mausoleum has changed significantly its original appearance after the restoration carried out in the 2000s. This is clearly evident in the comparison of the current appearance of the mausoleum with historical photos. The historical stones of the mausoleum were torn down and replaced with new ones during the restoration. These stones differ from the previous ones in their composition and color. As in the Karabakhlar Mausoleum, a tent-shaped dome was erected on top of the Gulustan Mausoleum. Certain artistic elements were placed on the new frieze formed at this time. Consider the following quote: “The pedestal is completed with a richly decorated cornice, upon which a dome rises. The upper parts of the building feature intricate and elegant crafted ornamentation. Since the very top of the mausoleum has not survived, it is impossible to say how high the building was once, but the current height of the mausoleum is 9 meters” [1]. As can be seen, a polyhedral dome was erected on top of the monument, although its historical height is unknown. Such situations evoke inevitably a sense of regret. Although the mausoleum looks more beautiful from the outside, it has lost its historical appearance (Fig. 1, 2).

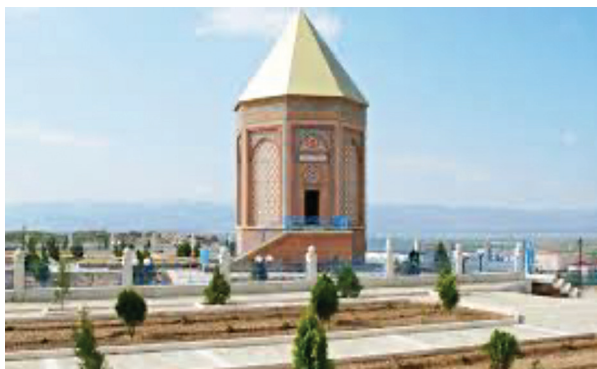
**Fig. 4. Mausoleum of the  
Prophet Noah. Modern view.**

The Mausoleum of the Prophet Noah is one of the monuments, appearance of which has been most significantly altered during the restoration work. Almost nothing remains of the original appearance of the mausoleum, which was restored in 2006; this prevents us from assessing the original artistic composition of the monument. However, it can be assumed that, like the Imamzadeh Mausoleum, the Mausoleum of the Prophet Noah had a relatively simple decorative design. The majolica decorations on the mausoleum are no exception. According to old photographs and watercolors by Bahruz Kangarli, the above-ground part of the mausoleum had long been in ruins by the early 20th century. The surviving foundation of the mausoleum indicates that it was octagonal [2]. However, nothing can be definitively said about its architectural composition. However, the facade of the mausoleum, which had not previously existed, was rebuilt in an octagonal shape and decorated with brick and blue tiles during the restoration. Furthermore, the upper part of the

mausoleum was designed in a tent-like shape and its surface was covered with a layer of gold-colored metal (Fig. 3, 4).

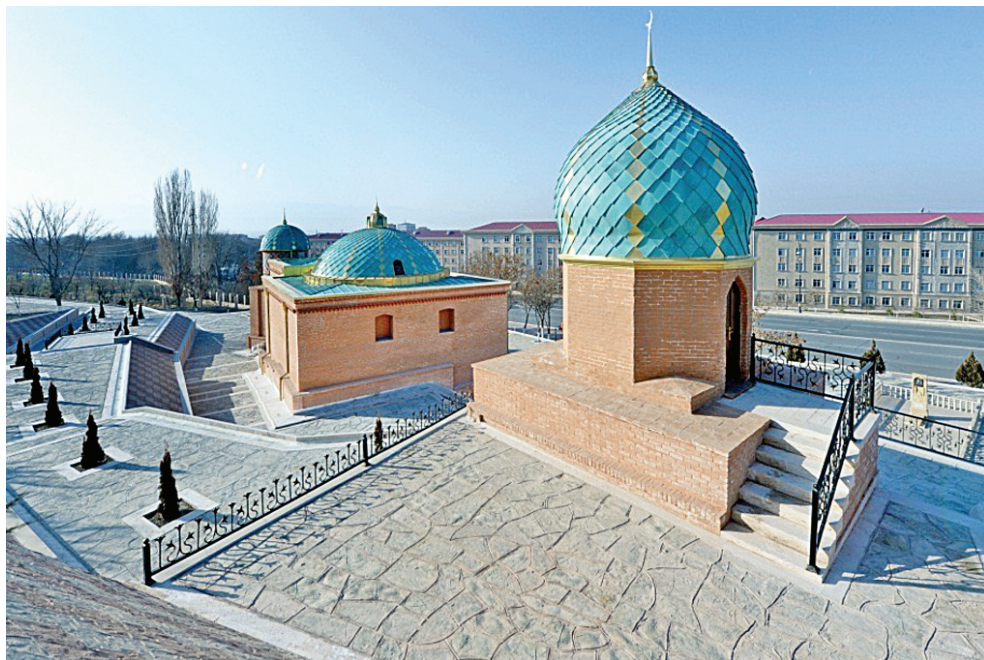
**Fig. 6. Nakhchivan Imamzadeh Mausoleum. Modern view.**

**Nakhchivan Imamzadeh Mausoleum.** The Imamzadeh Mausoleum is located in Nakhchivan. There was once an inscription on the northwestern facade of the Mausoleum. The inscription states in Naskh script that the mausoleum was built in 1722-32 [5]. This mausoleum is also depicted in Bahruz Kangarli's watercolors. The artist depicted the mausoleum from various angles. This provides a relatively detailed picture of the appearance of the mausoleum in the early 20th century. The paintings show clearly that the small rectangular part of the mausoleum adjacent to the main hall is decorated with majolica. The word "Allah" is repeated here, which is reminiscent of the Karabakhlar Mausoleum [6]. This composition was preserved in its original form during the restoration. But the same cannot be said about other parts of the mausoleum. Kangarli's watercolors show clearly that the small, separate part of the Imamzadeh Mausoleum was covered with white plaster. The monumentality characteristic of the Atabegs era disappeared, and monuments began to be built in a smaller scale and with less decoration in the 18th century architecture. The plastering of brick walls is precisely related to this. Since decorative elements were no longer used on bricks at that time, simple facing plaster was used. However, like other monuments, the Imamzadeh Mausoleum was covered with a new layer of bricks after the restoration. So, the original appearance of the monument has completely changed, only the form has been preserved. Even the form is not exactly the same as before. For example, both the shape and material of the dome of the small part have been completely changed, and there is no trace of the painting by Bahruz Kangarli (Fig. 5, 6).
